# JOURNAL OF FORENSIC MEDICINE SCIENCE AND LAW

## Case Series

### Autopsy in Occupational Blasts- A Case Series.

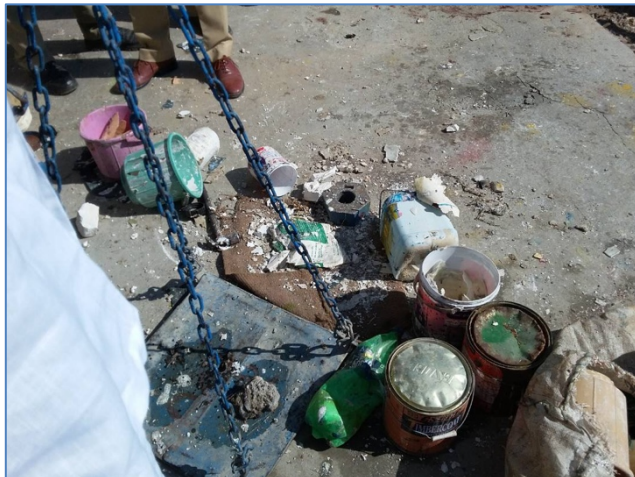
**Figure 1:** Crime Scene showing the fragments of the chairs along with the exploded Tin

the limits of Narsingi police station. The deceased sitting on a chair attempted to break open half used ten-liter paint tin by placing it on the floor between his both legs. The tin suddenly exploded causing severe blast injury (Fig. 1). The blast also set two 'shrapnel' among multiple fragments of tin into projectile motion. The scrap tin projectiles entered the abdomen of the deceased by penetrating through his right groin and caused widespread trauma leading to his death. A bomb disposal squad and a team of forensic experts made a preliminary assessment at the blast scene and made out it to be a prima facie compression blast. Physical evidence was collected at the scene for subsequent final opinion. The corpse was subjected to autopsy at Medico legal center, Osmania General Hospital, Hyderabad.

Any remnants of thinner used in painting or thinner soaked cloth material might have supposedly caught fire due to a spark generated on sudden strike of axe on the iron lid. Burning of thinner material might have generated gasses which found difficult to get out through the small vent created by the deceased. The compression generated thereby might have led to a blast. Few other things like a plastering trowel piece left in the tin may have taken a projectile course. Thinner used in paints contains Mineral spirits/ white spirit, Acetone, Turpentine, Naphtha, Toluene, Methyl ethyl ketone (MEK), Dimethyl formamide (DMF), 2-Butoxyethanol, or any of the other glycol ethers which are potential inflammable materials

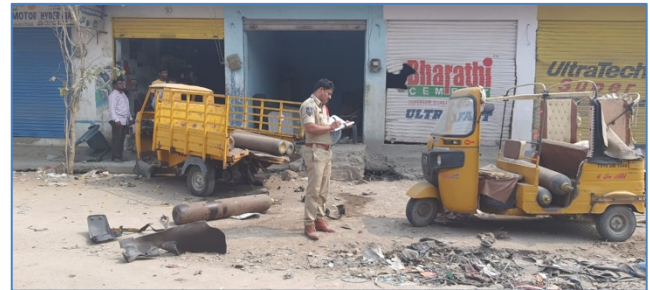
**Figure 2:** Crime Scene showing exploded oxygen cylinder along with the trolley of the auto.

On the fateful morning of 23/03/2021, the deceased a 28-year-old man and his friend were manually loading oxygen cylinders in their auto at their workshop within the limits of town VI police station, Nizamabad. One of the oxygen cylinders exploded while being placed on the trolley of the auto and caused fatal injuries to the deceased leading to his death on the spot (Fig. 2).

Sudden breaking of pressure/flow regulator knob of the oxygen cylinder while placing it in the trolley of auto led to a sudden decompression of pressurized oxygen leading to a heat and blast wave generation which led to shattering of glass and

disruption in scene and death of individuals handling the cylinder.

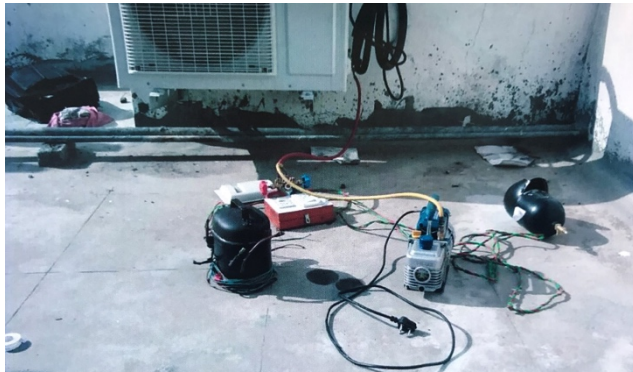
**Figure 4:** Crime scene showing the exploded compressor along with the equipment.

A 28-year-old male, working as an AC technician in Hyderabad city attended for repair and Service of split AC in an apartment along with his untrained helper on 23/06/2017 at 10 am. During the process of repair of the split AC, he needed to refill the gas (Fig. 4). So, he started gas filling and assigned his helper to supervise the task and left for attending some other work. When he returned and inspected the process of refill, the compressor of the outdoor unit exploded suddenly. The AC technician sustained a fall from height and was later shifted to OGH Hyderabad for treatment where doctors declared him brought dead and shifted to mortuary for post mortem examination.

Failure of the valve that regulated pressure/volume flow in to the AC compressor led to

increased thrust of the gas inside, which led to sudden explosion.

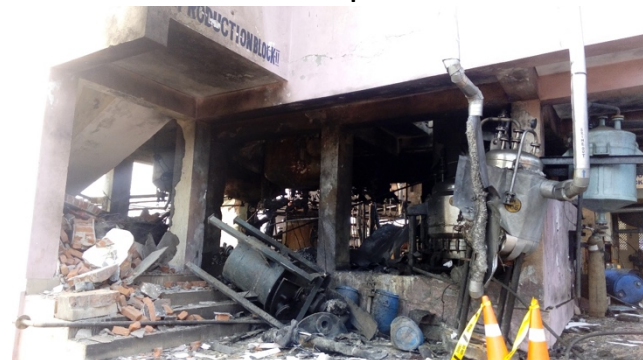
**Figure 7:** Crime scene showing the rubble due to collapse of wall as a result of reactor explosion.

A 22-year-old male, working as helper in a pharmaceutical company was on duty. On the early hours of 08/02/2016 at around 6:15 am the Nutsche filter attached to reactor exploded resulting in the death of the individual who was working in the reactor room (Fig. 7). During the post mortem examination, the head of the individual is severed from the trunk at the level of C6 and C7 vertebrae. The trunks along with upper limbs are completely mutilated and all the internal organs are dissipated across the room, bowels charred with deposition of shrapnel on the body parts (Fig. 7-10). Skin was hardened due to the chemical spillage on them. The cause of death was hemorrhagic shock due to multiple injuries. The manner of death was accidental.

Industrial safety experts concluded that pressure dysregulation within the agitated nutshce filter lead to a reactor blast causing the fatalities.
